SOUTH WINDSOR TOWN-WIDE ADA ASSESSMENT

SILVER / PETRUCCELLI + ASSOCIATES

Final Report: May 2, 2022

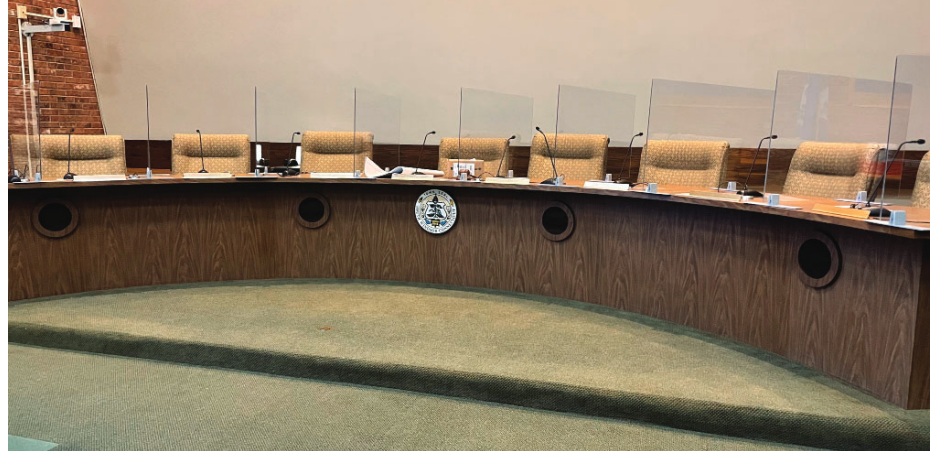
Platform Condition in Council Chamber, Main Level

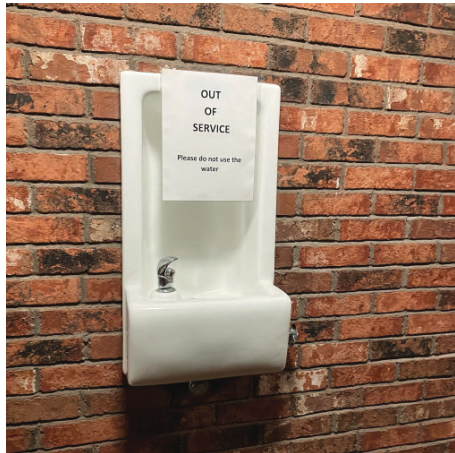
Drinking Fountain, Main Level Corridor

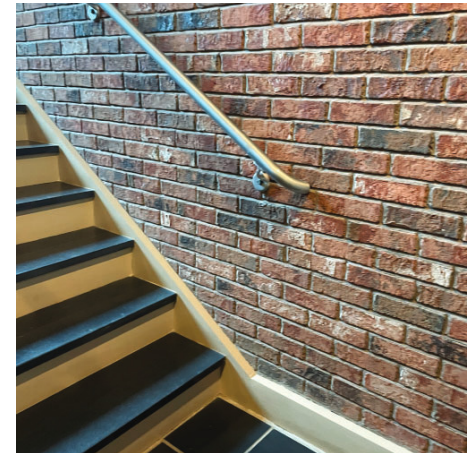
Handrail Condition, Stair B

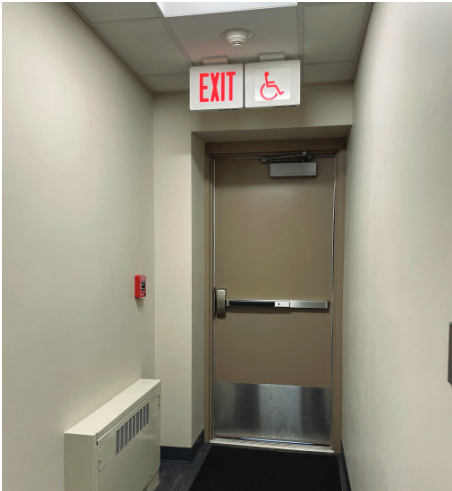
Rear Entrance Condition

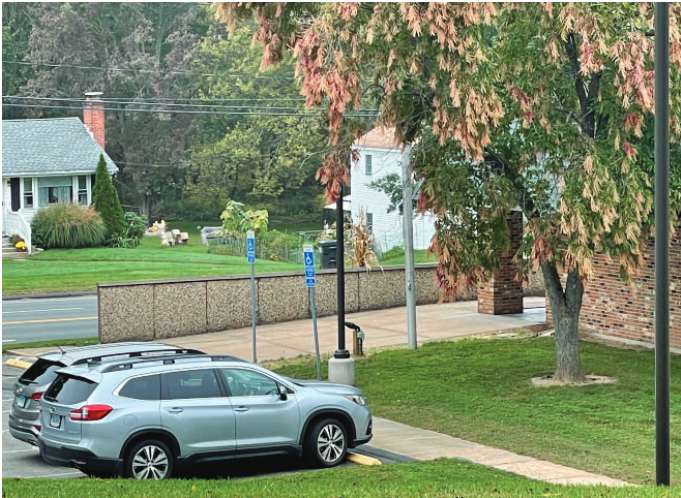
Ramp to Main Entrance, View from Town Hall Parking Lot

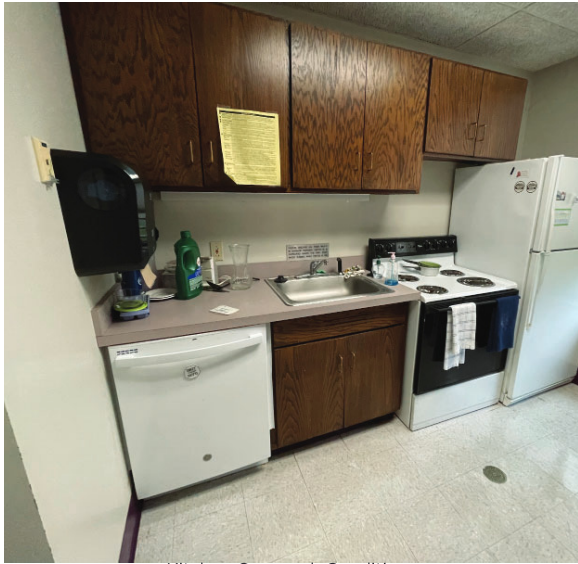
Kitchen Casework Conditions

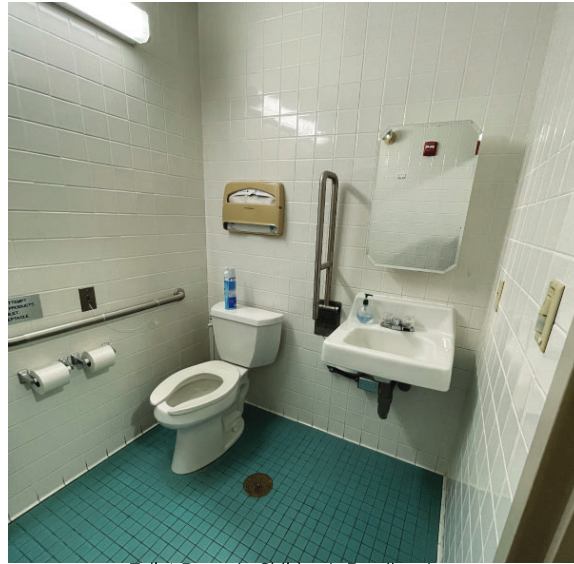
Toilet Room in Children's Reading Area

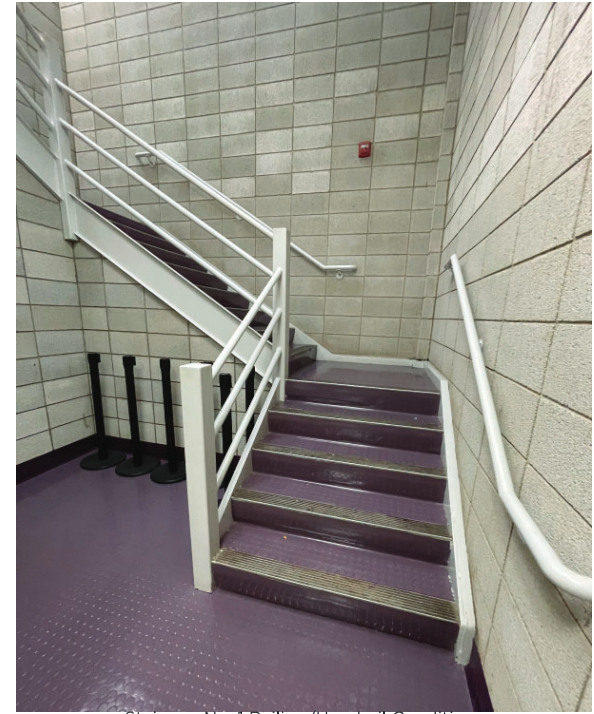
Stairway No. 1 Railing/Handrail Conditions

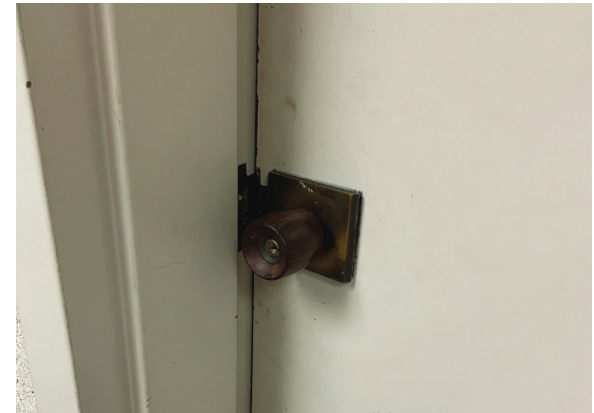
Door Hardware Condition

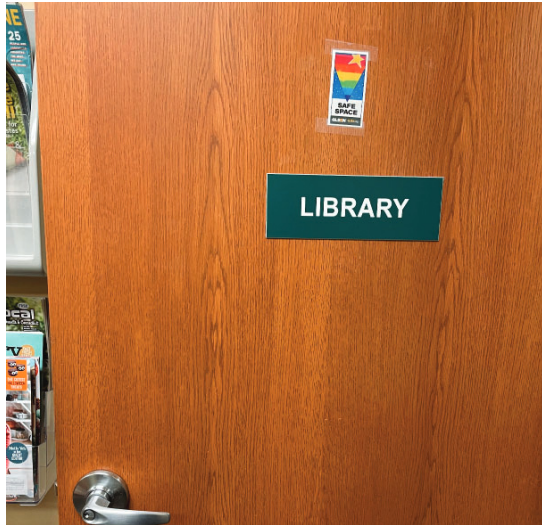
Signage Condition, All Spaces

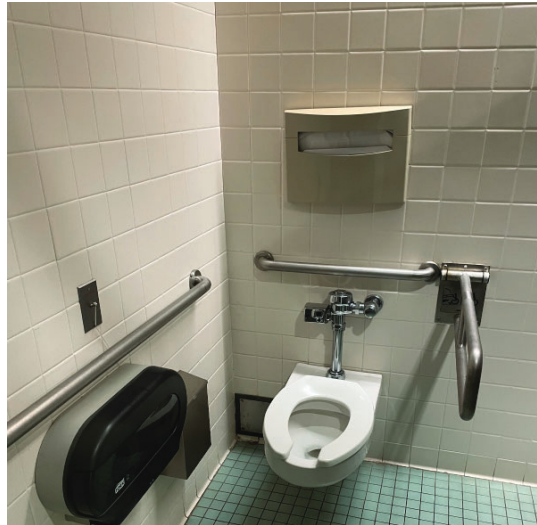
Women's Toilet Room, Compliant Stall Condition

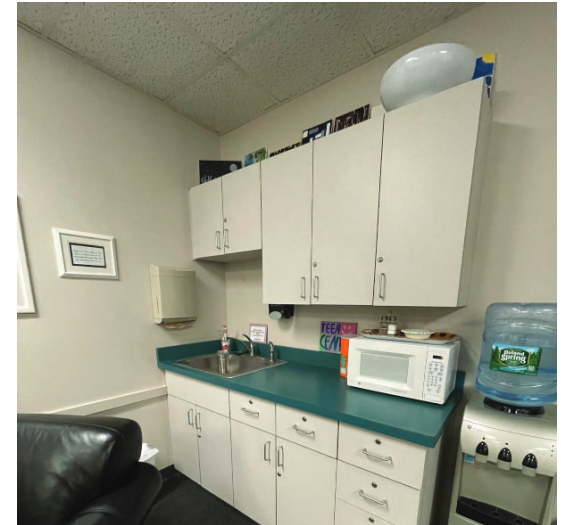
Kitchenette Condition, No Compliant Knee Space

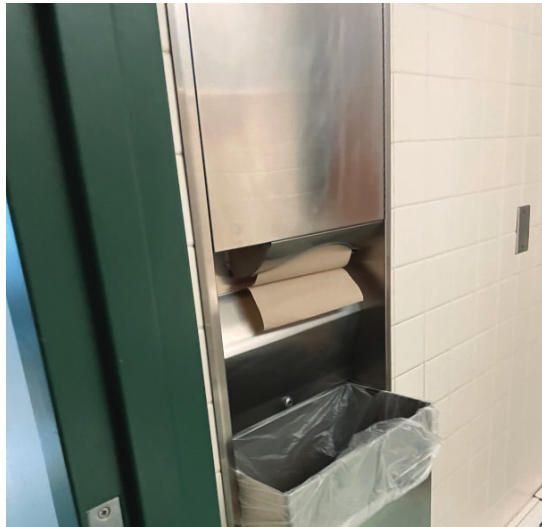
Corner Condition, Toilet Room

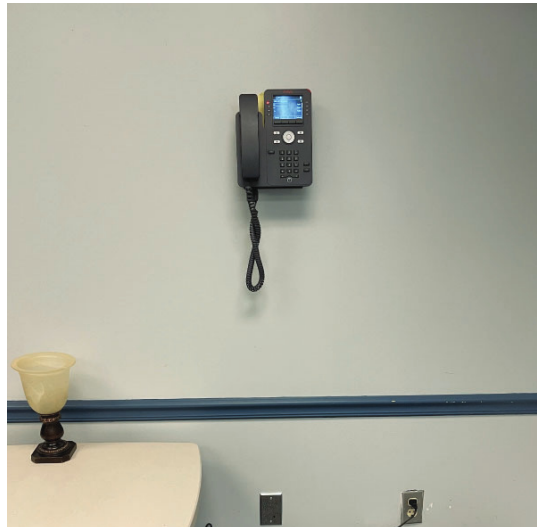
Telephone Mounting Condition, All Applicable

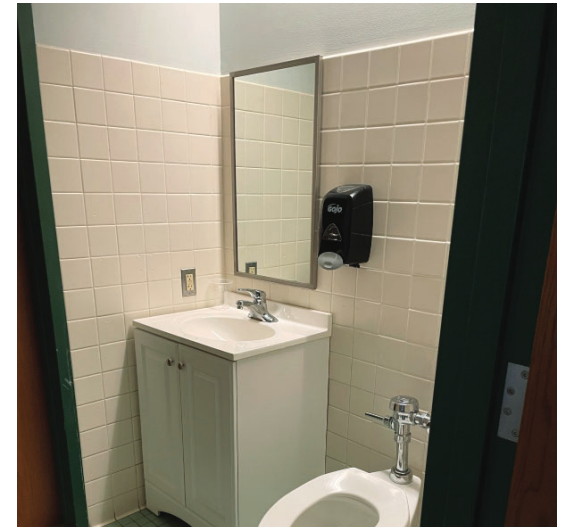
Toilet Room Layout Condition

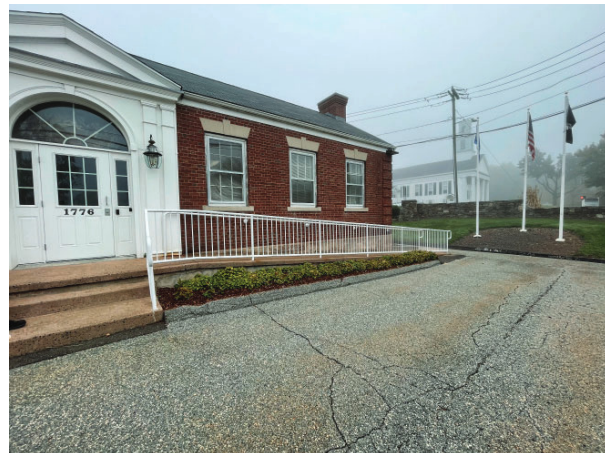
Front Entrance Condition

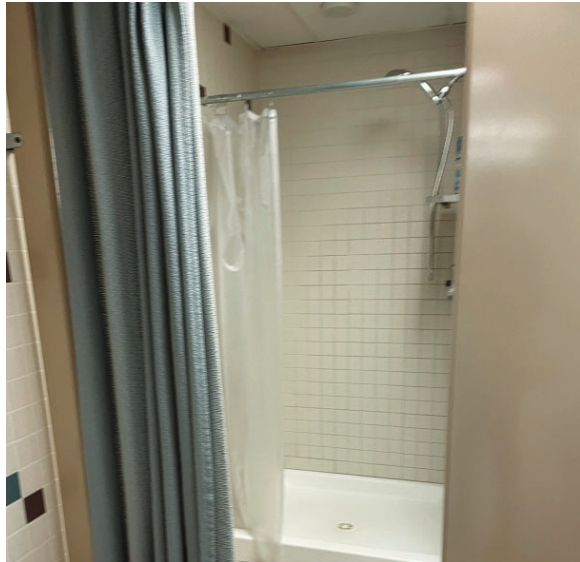
Shower Condition, Locker Rooms

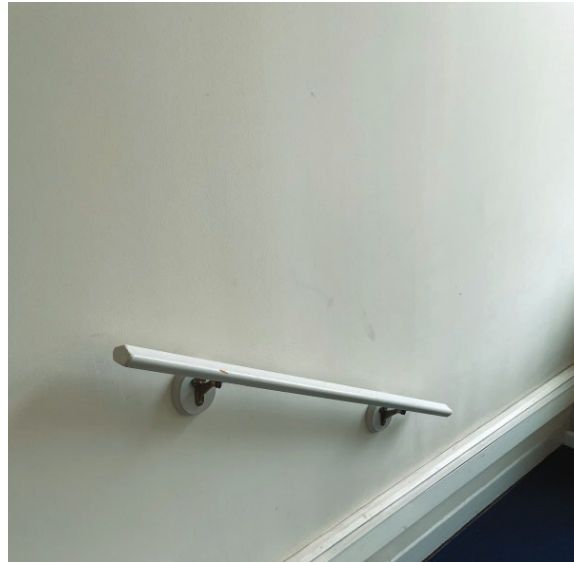
Handrail Condition, Front Entrance

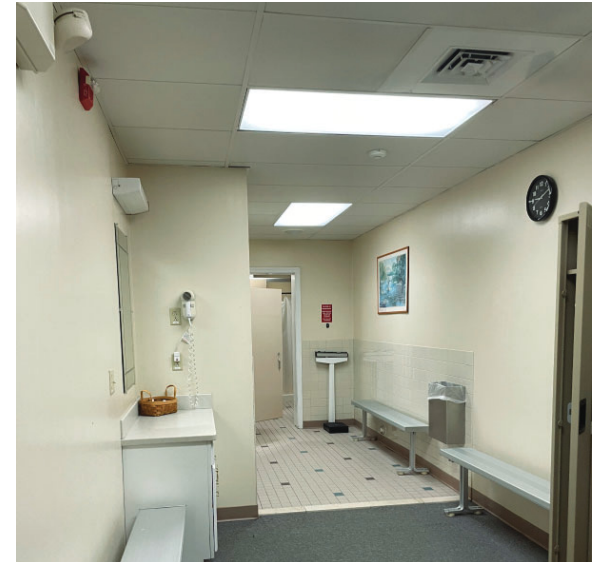
Locker Room Condition

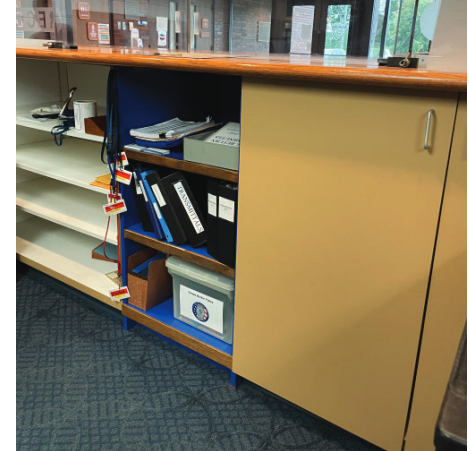
Casework Conditions, Reception Deck Upper Level

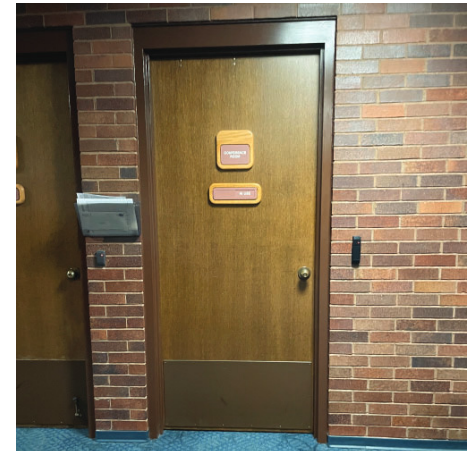
Signage Condition, Both Levels

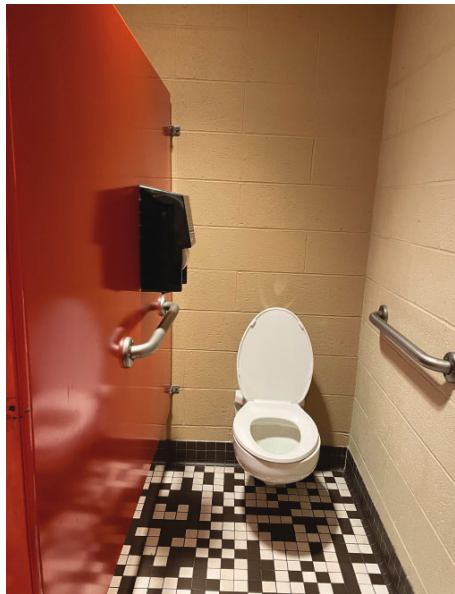
Stall and Grab Bar Conditions

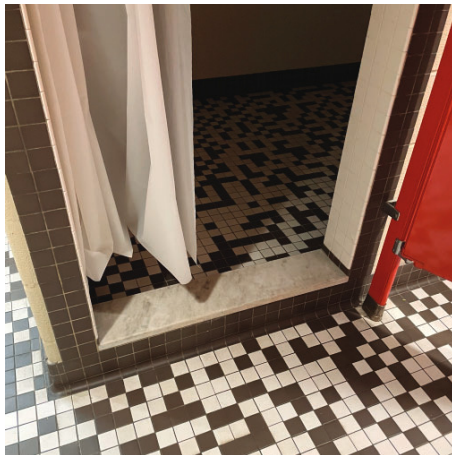
Shower Sill Condition

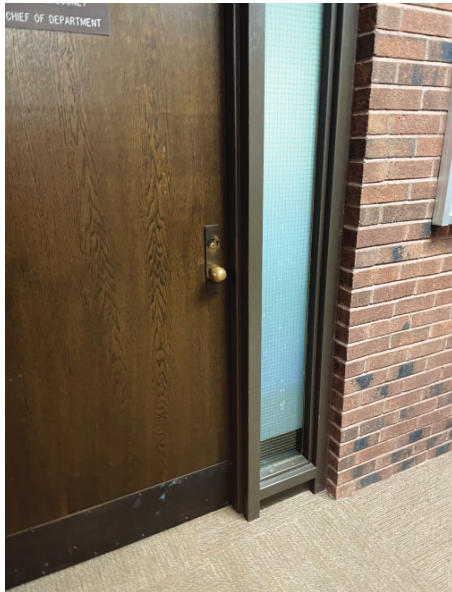
Door Hardware, Fire Chief's Office

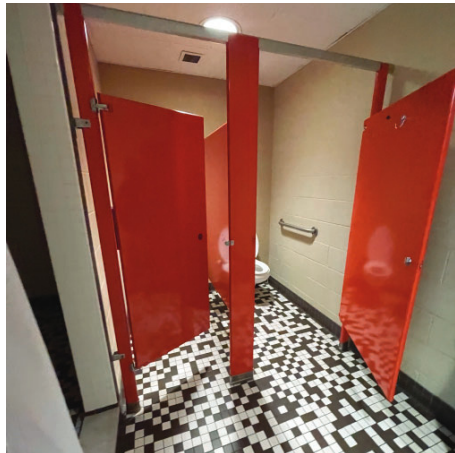
Stall Clearance Condition

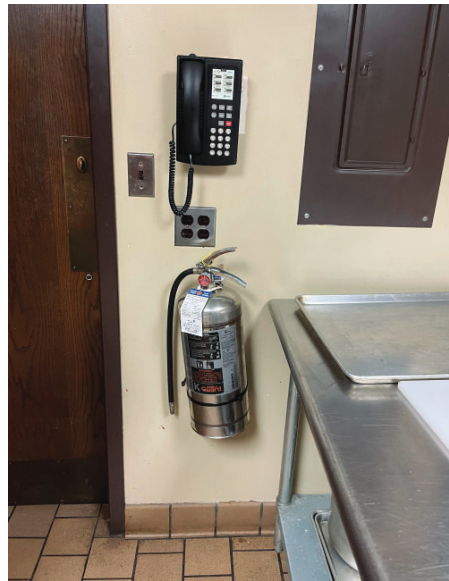
Clearance Condition, Kitchen Area

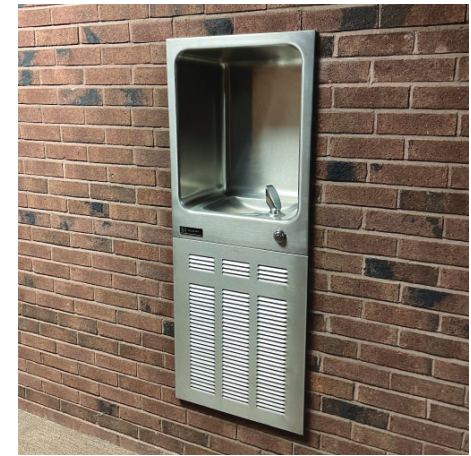
Drinking Fountain Condition, Corridor

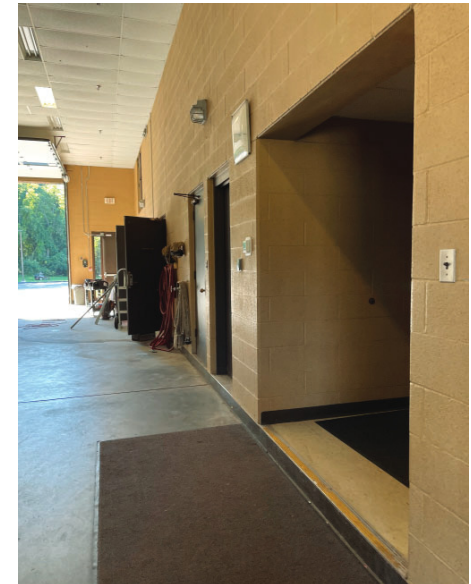
Floor Condition, Apparatus Bay

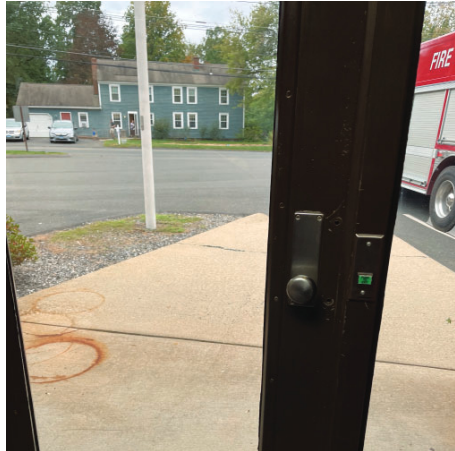
Door Condition, Main Entrance Area

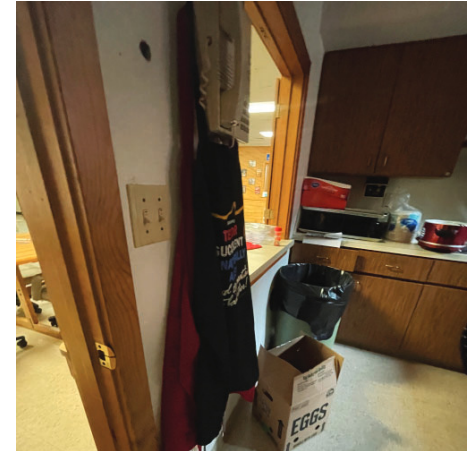
Countertop Condition, Kitchen

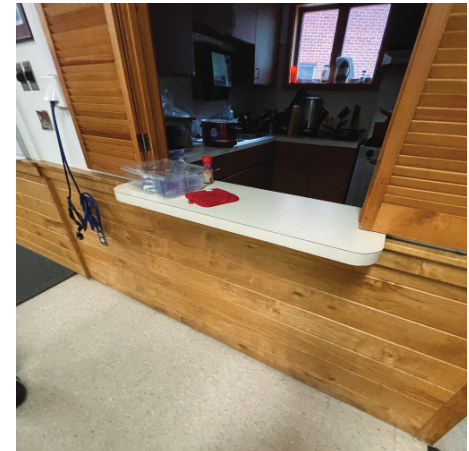
Countertop Condition, View from Multi Purpose Room

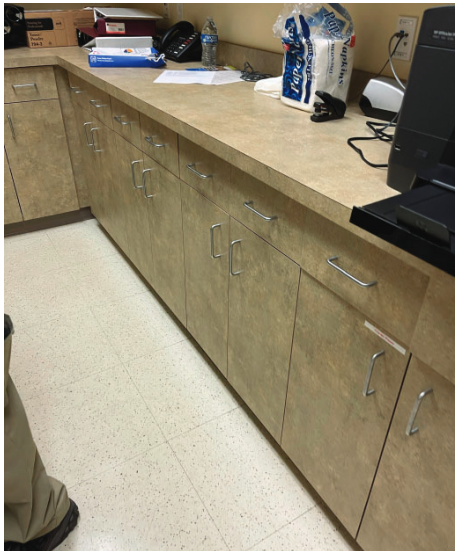
Casework Condition, Copy/Mail Room

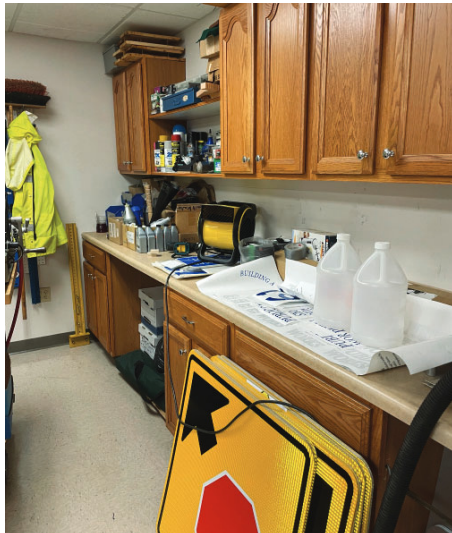
Casework Condition, Break Room

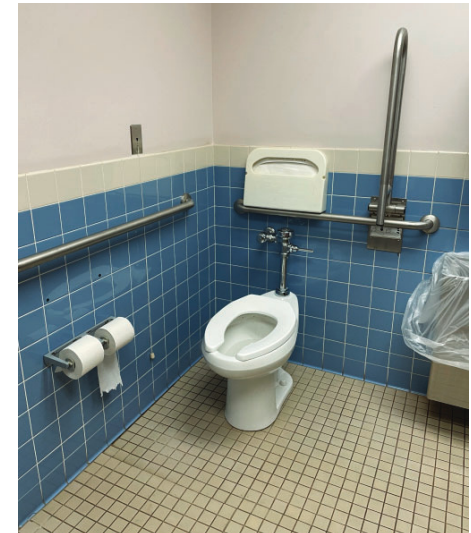
Restroom Condition, Adjacent to Reception Area

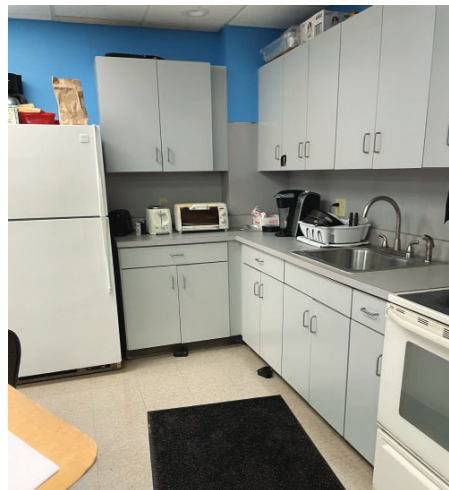
Casework Condition, Lunch Room

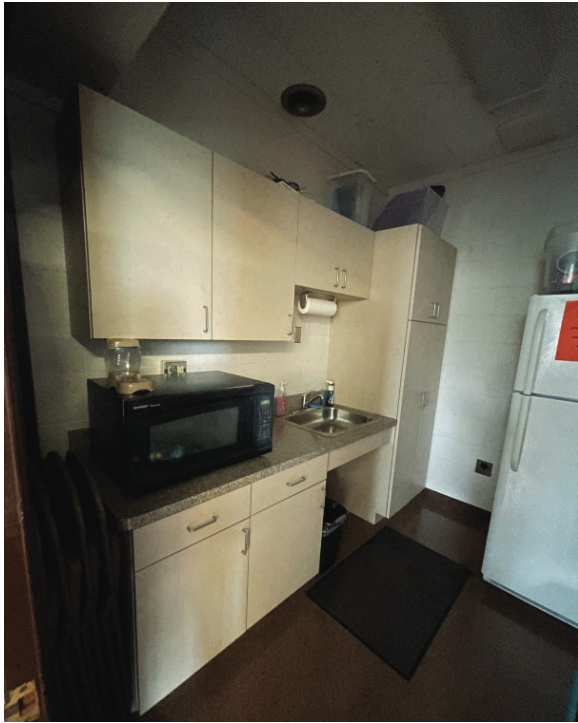
Kitchen Casework Condition

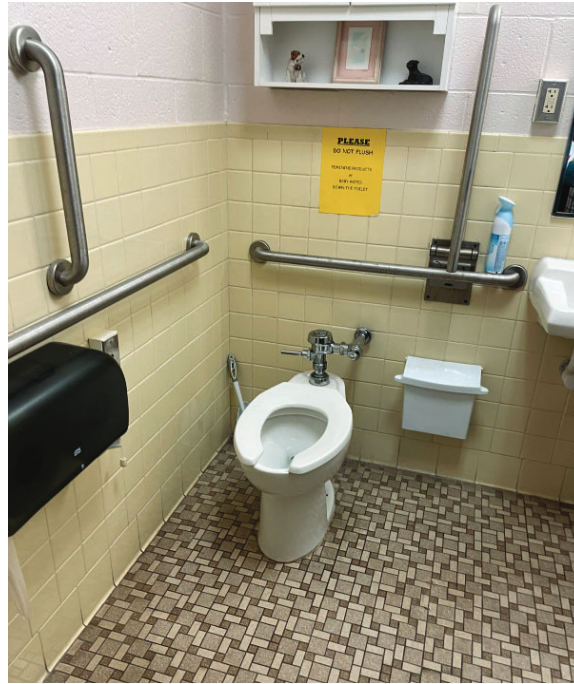
Toilet Room Conditions

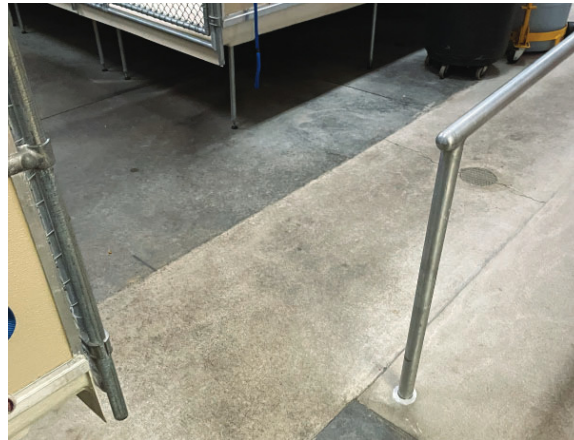
Railing to Kennel Condition (Circulation)

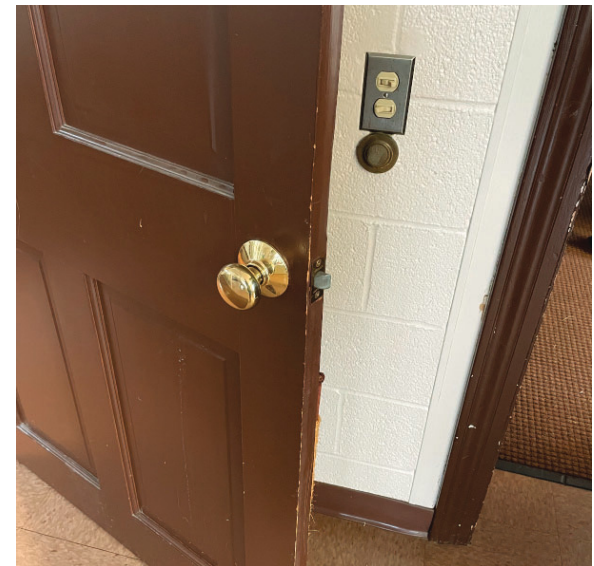
Door Hardware Condition

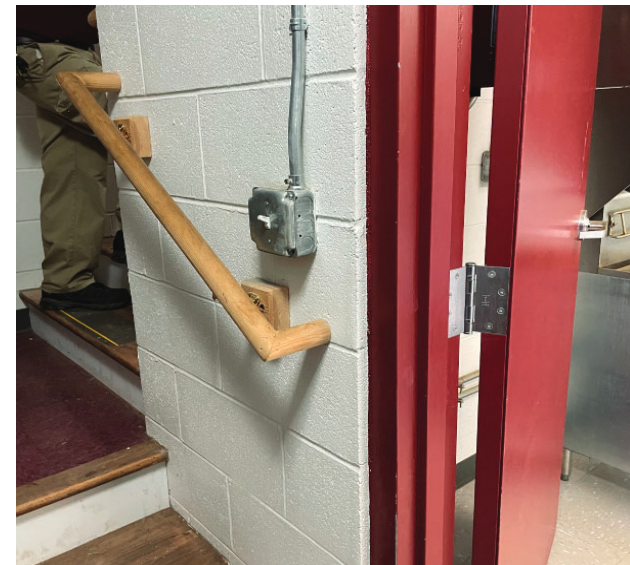
Handrail Extension Condition

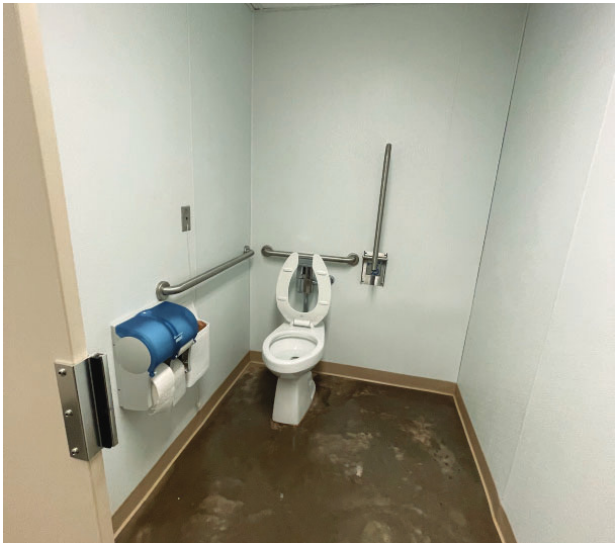
Stall Layout Condition

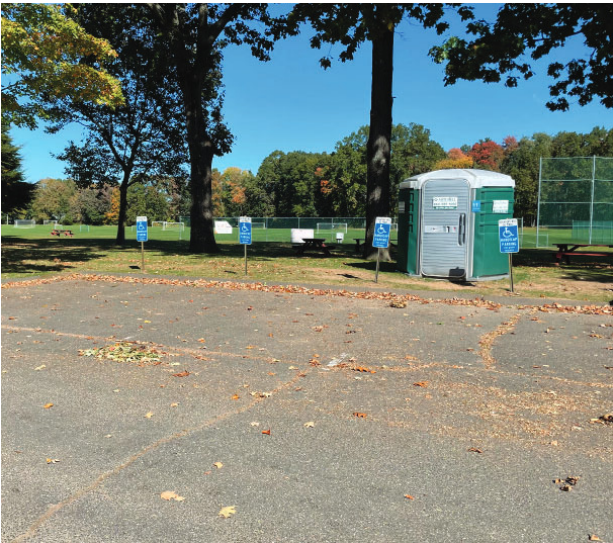
Handicapped Parking Space Signage, Not Compliant

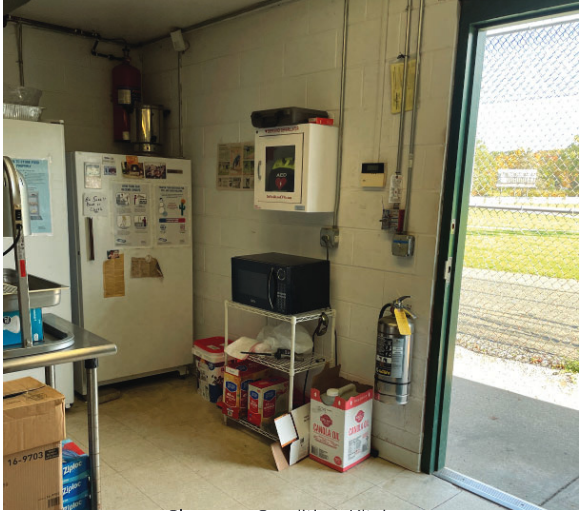
Clearance Condition, Kitchen

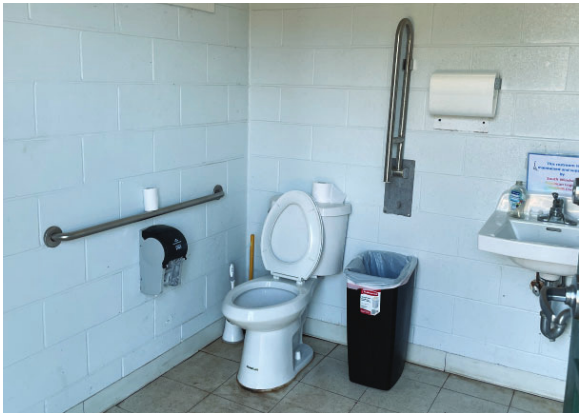
Toilet Room Condition, Adjacent to Concessions/Kitchen Area

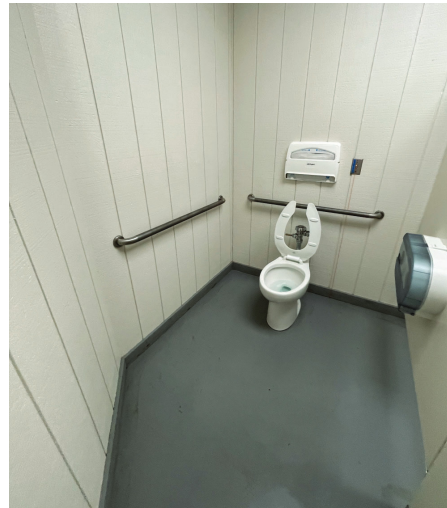
Stall Conditions, Toilet Room

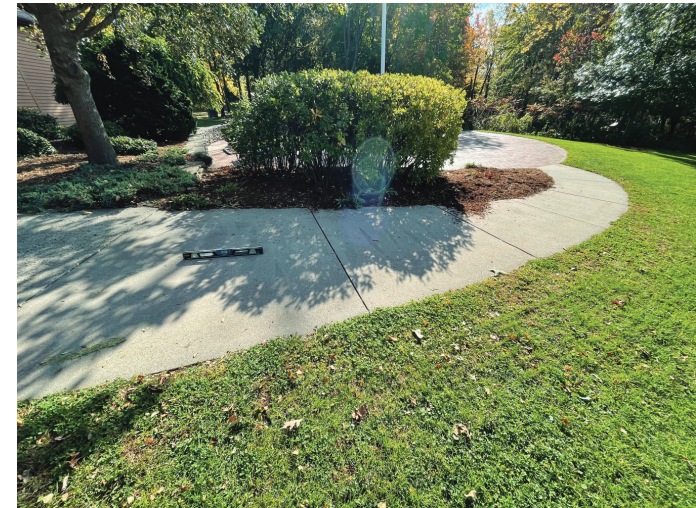
Exterior Ramp Condition, West of Pavilion
