SOUTH WINDSOR TOWN-WIDE ADA ASSESSMENT

SILVER / PETRUCCELLI + ASSOCIATES

Final Report: May 2, 2022

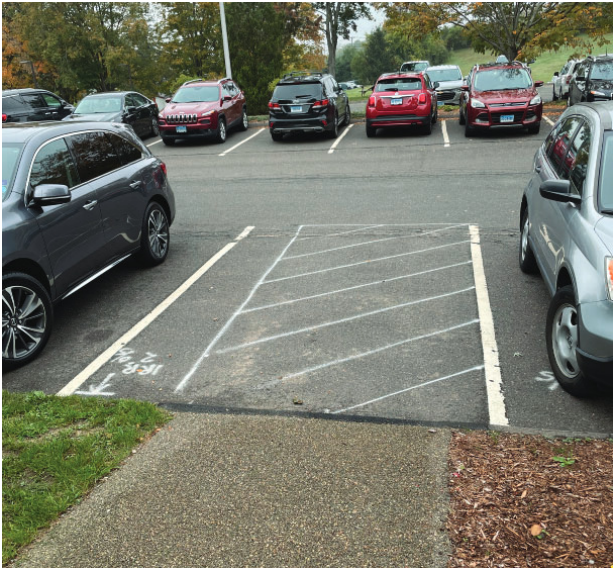
Pedestrian sidewalk from lower parking lot

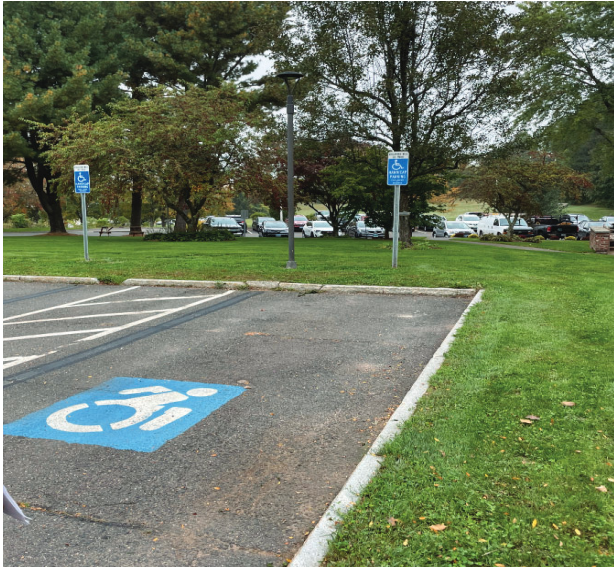
Lack of accessible route at upper parking lot

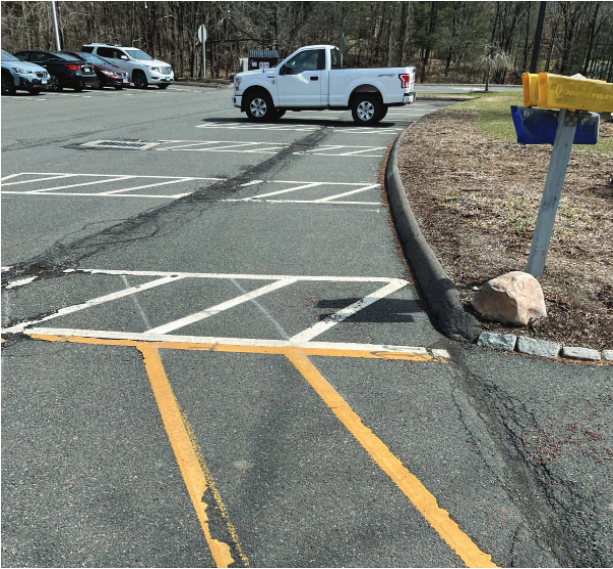
Lack of accessible route at lower parking lot

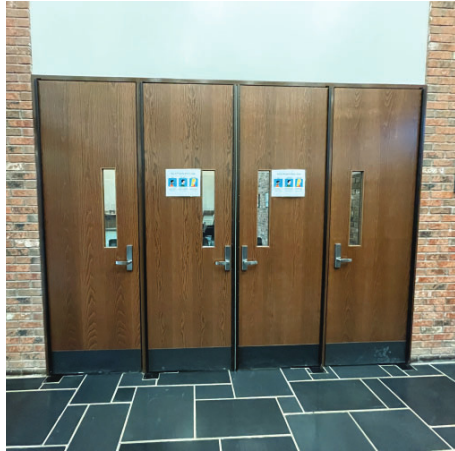
Main Doors to Council Chambers

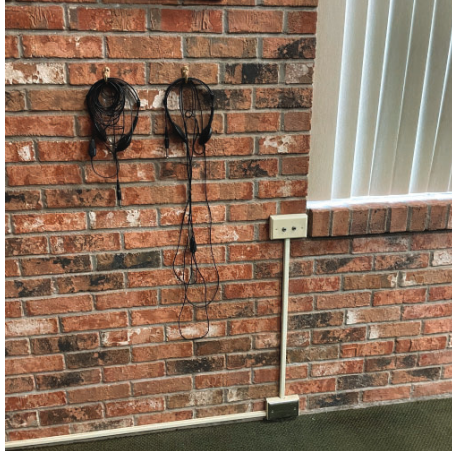
Assistive Listening System, Council Chambers

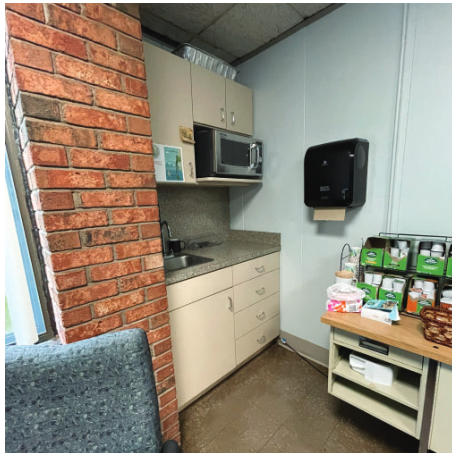
Kitchenette Condition, Lower Level Lounge Area

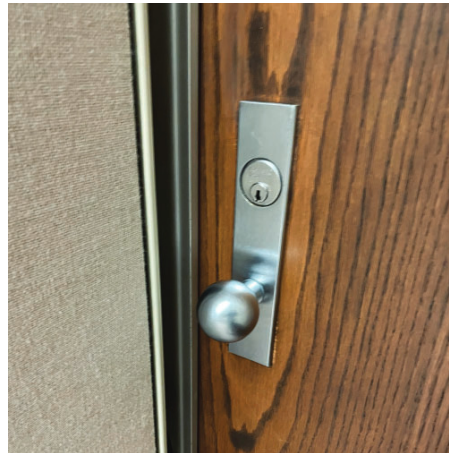
Door Condition, Multiple Areas

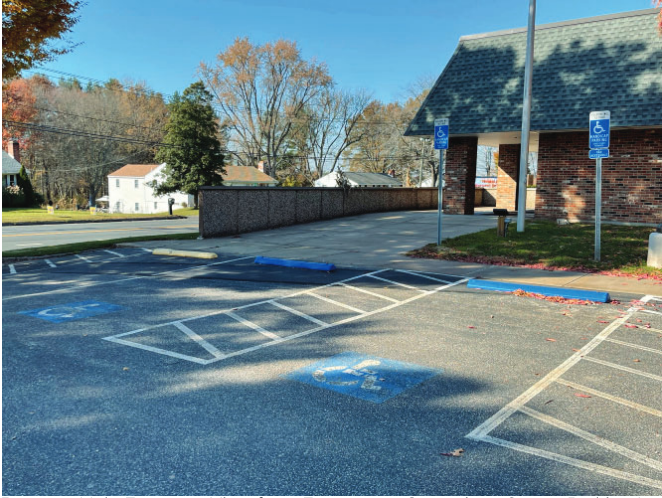
Ramp to Main Entrance, View from Emergency Operations Center Parking Lot

1.30 - Ramp rise is higher than 6", requiring handrails

1.37 - Lack of handrails results in a nonaccessible entrance

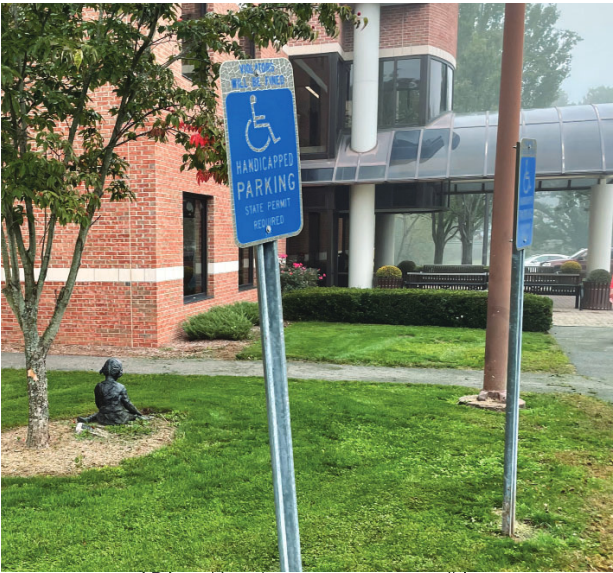
ADA parking signage, no van accessible

1.3 - There is no van accessible space

1.11 - No sign for van accessible space

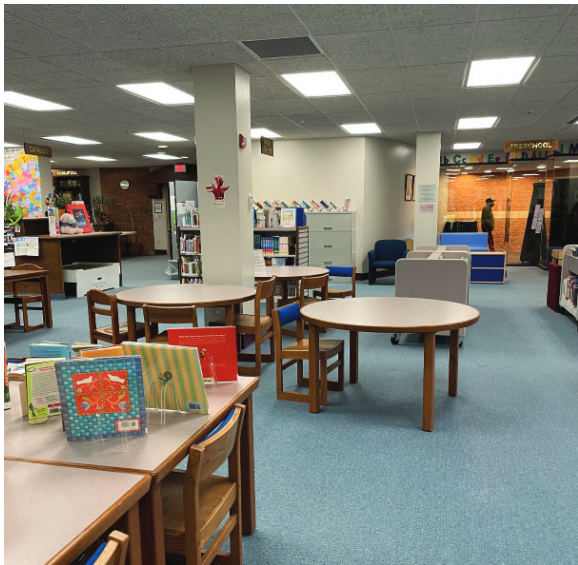
Children's Reading Area

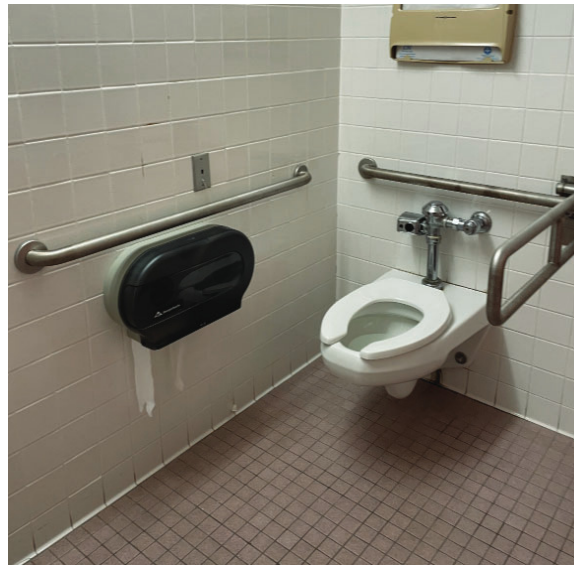
No vertical grab bar

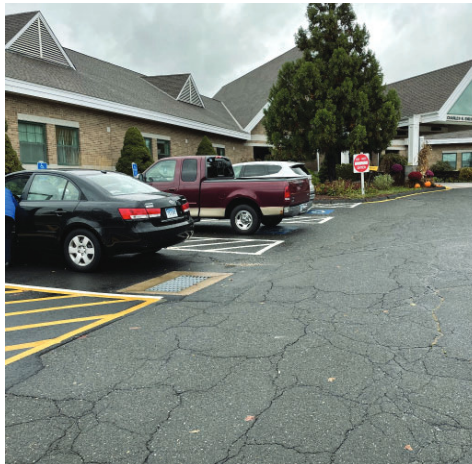
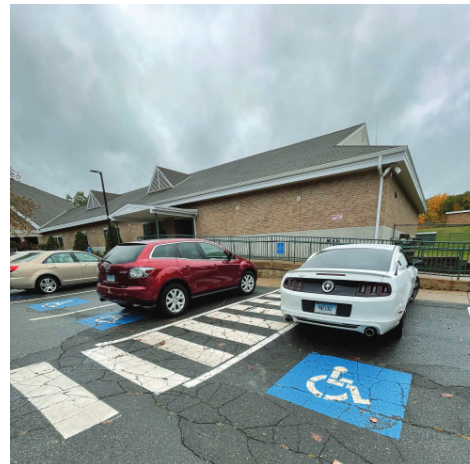
View of Handicap Parking Spaces

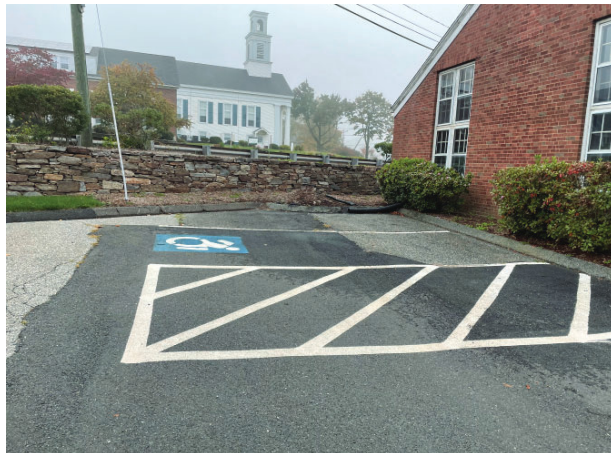
Handicapped Parking Space, Adjacent to Fitness Area

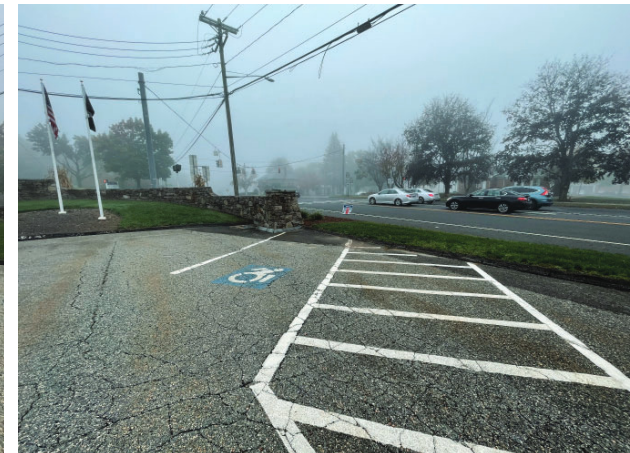
Handicapped Parking Spaces, Adjacent to Front Entrance

1.11 - No van accessible parking sign

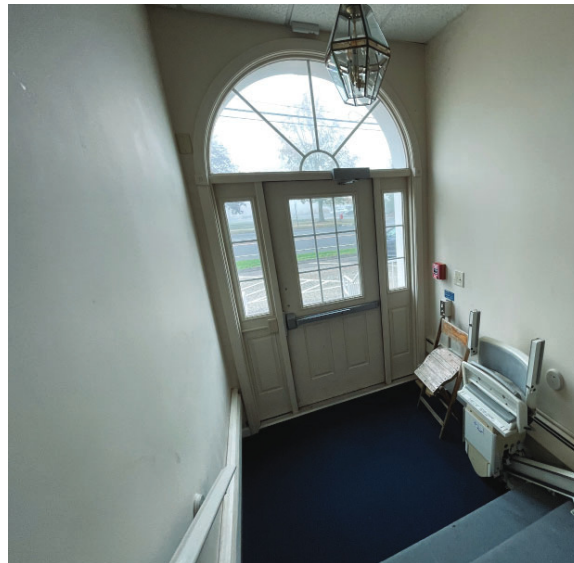
Front Entrancem, View from Top Step

1.37/1.42 Front entrance does not have 60" clear depth at door

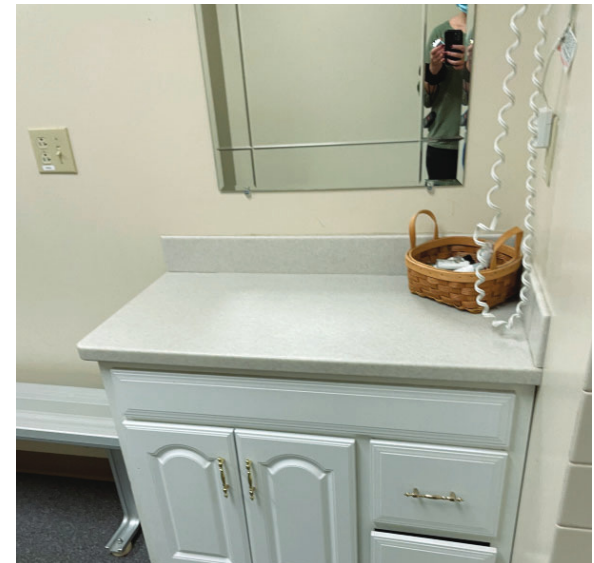
Locker Room Casework Counter

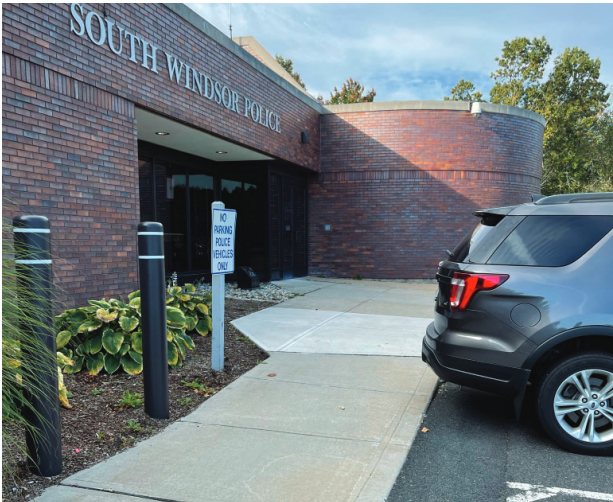
The main priorities of this building are mostly of Priority 1, Exterior Conditions, and Priority 3, the Locker Room/ Restroom areas. As seen in the photo on the current page, the slope of the concrete sidewalk is steeper than the compliant slope listed in the American Disabilities Act. The following page reviews photographs taken during the building's assessment, showing conditions like the lack of counter space or the maximum height required. The drinking fountain is also a significant item which will need to be updated along with the addition of grab bars in accessible toilet rooms. This building was reviewed on September 17th, 2021.

Main Entrance, View from Accessible Parking Spaces

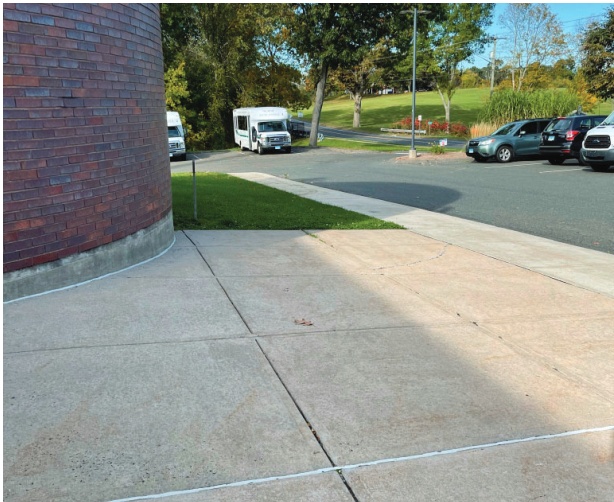
Sidewalk/Drop-off Zone

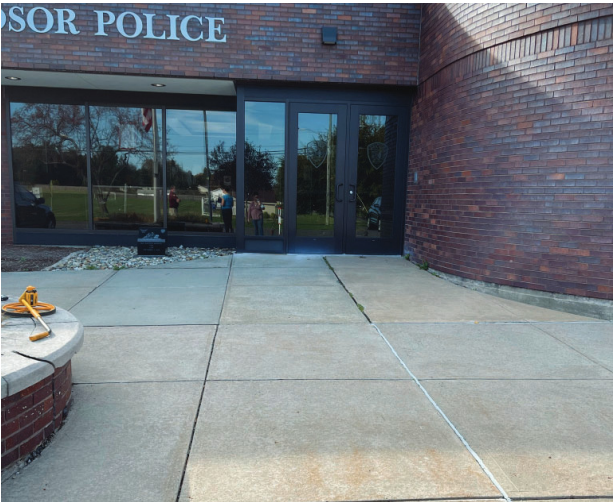
Main Entrance, View from Drop-off Zone

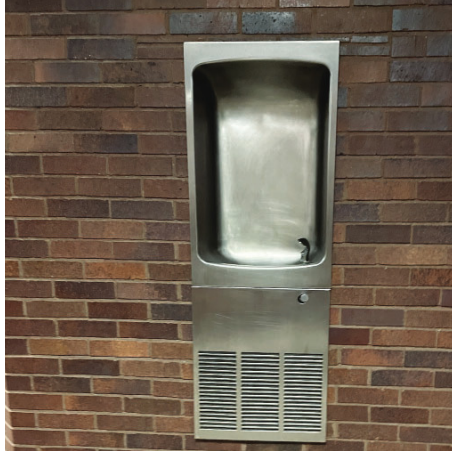
Drinking Fountain, Corridor at Lower Level

4.2 - 4.7 - Drinking fountains at lower level are not compliant

PRIORITY#	ADA VIOLATION	ADA PRIORITY	CORRECTIVE ACTION	UNIT	TAKEOFF QUANTITY	ITIMIZED ESIMATED COST	TOTAL COST	REMARKS
		1 2 3 4						
4.1-4.9	Drinking Fountain not compliant		Install new drinking fountain to meet code compliance	EA	2	\$2,500	\$ 5,000

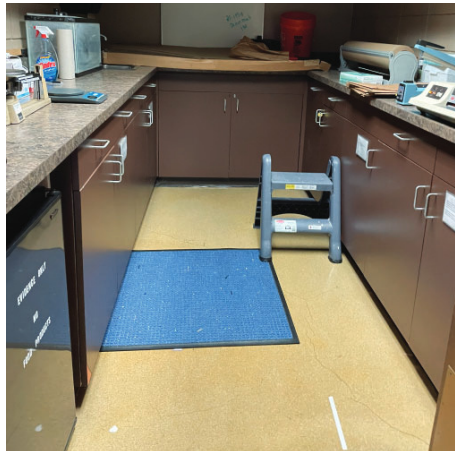
Countertop area, Report Writing Space at Lower Level

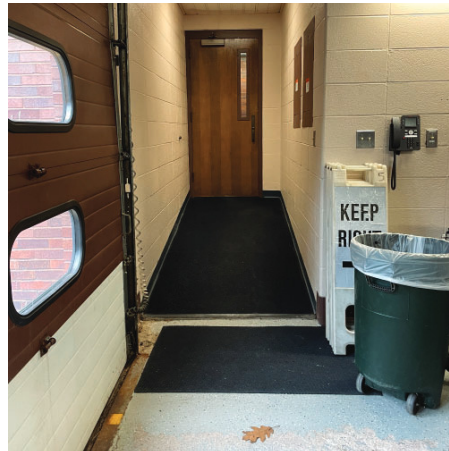
Ramp Condition, Ambulance/Vehicle Bay at Lower Level

no	yes	yes									
Controls	2.50	2.51										
	yes	yes										
Benches - locker rooms	2.69	2.70										
	no	no										
Sales & Service counters	2.76	2.77	2.78	2.79	2.80							
	no	N/A	no	N/A	no							
Stairs	2.89	2.90	2.91	2.92	2.93	2.94						
	yes	no	yes	no	yes	N/A						
Summary - 2.6 & 2.12 - Ramp running slope steeper than 1:20 2.13 - No landing at top of ramp 2.15 - No handrails at ramp 2.38 - Room signage is not compliant 2.41 - Push/pull door clearances not compliant 2.43 - Door hardware is not compliant 2.69/.70 - Locker room benches not compliant 2.76/.78/.80 - Counter height/knee space not compliant 2.90 - Stair treads not compliant 2.92 - Stair handrail extensions not compliant

PRIORITY#	ADA VIOLATION	ADA PRIORITY	CORRECTIVE ACTION	UNIT	TAKEOFF QUANTITY	ITEMIZED ESTIMATED COST	TOTAL COST	REMARKS
		1 2 3 4						
2.6-2.15	Ramp in Ambulance Bay area is too steep & there is no landing at	2	Reconfigure- Ambulance Bay or adjacent spaces	LS	1	\$25,000	\$ 25,000

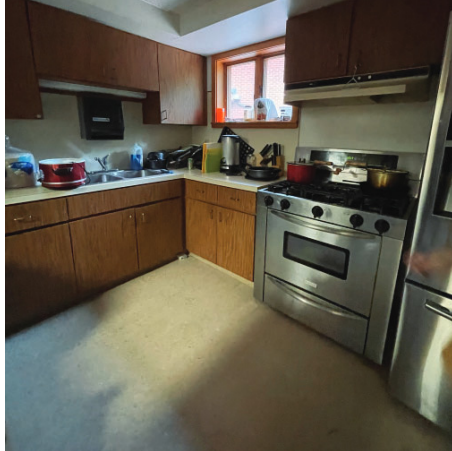
Kitchen Condition, no knee space

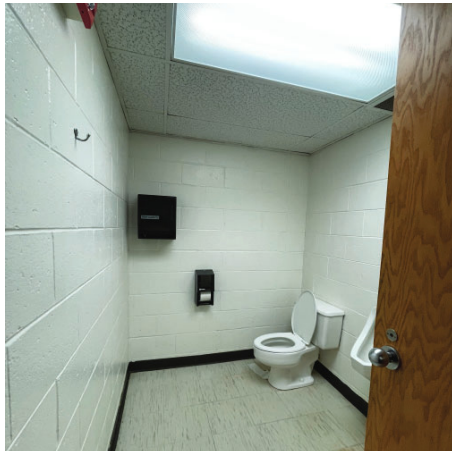
Restroom Condition, Adjacent to Multipurpose Room

PRIORITY #	ADA VIOLATION	ADA PRIORITY	CORRECTIVE ACTION	UNIT	TAKEOFF QUANTITY	ITIMIZED ESIMATED COST	TOTAL COST	REMARKS
		1 2 3 4						
3.31	Required clearance not provided around water closet	3	Alter toilet room for clearance	EA	1	\$50,000	\$ 50,000	Includes all priority 3

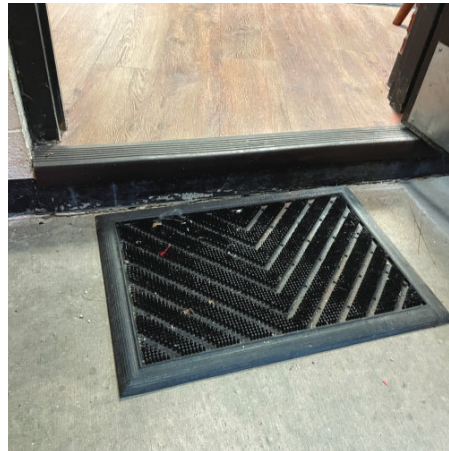
Floor Condition, Outside of Radio Room Area

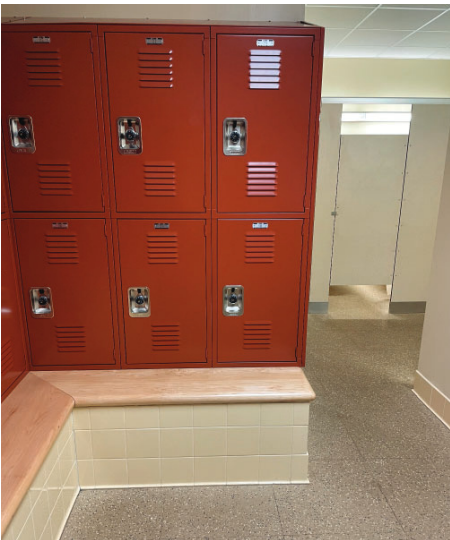
Bench in Locker Room, Not Compliant

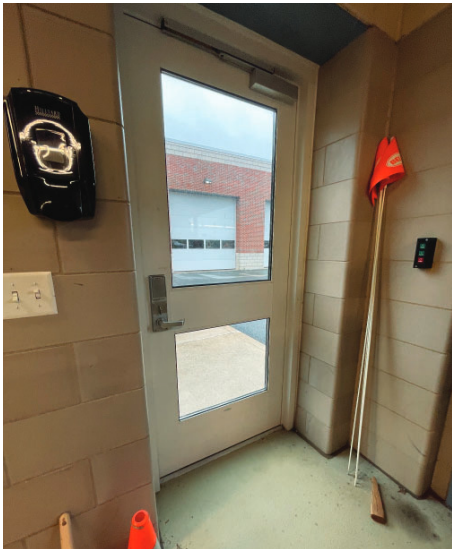
Door Clearance At Exit Door

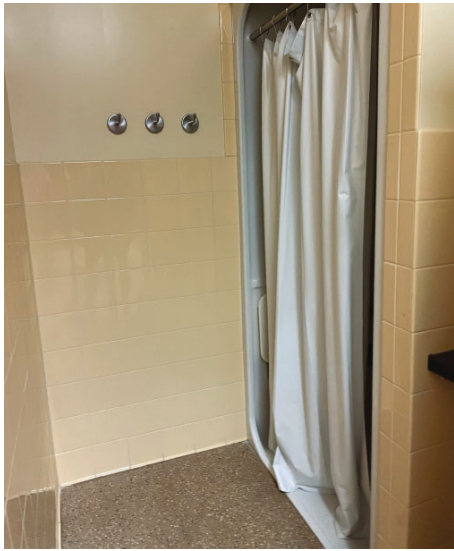
Hook Access at Shower, Locker Room

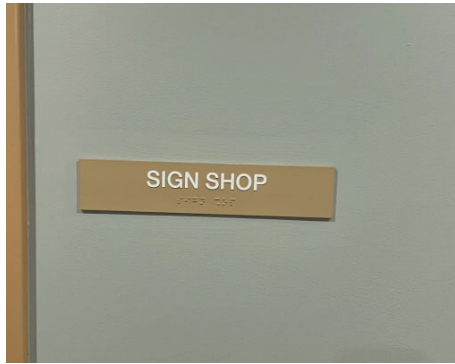
Signage Condition Throughout the Building

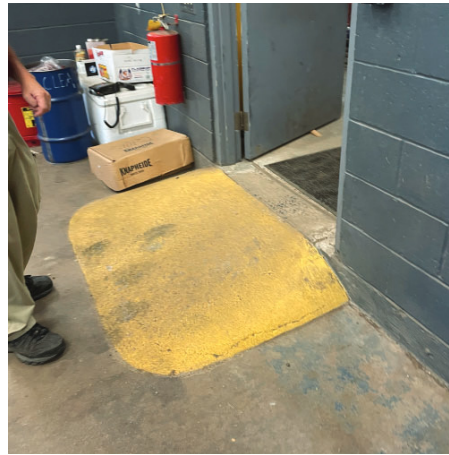
Ramp Condition, Doorway from Garage to

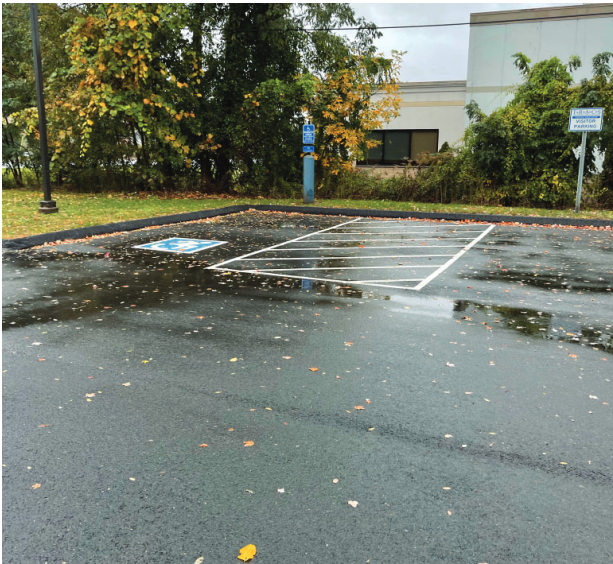
Handicapped Parking Spaces, Not Compliant

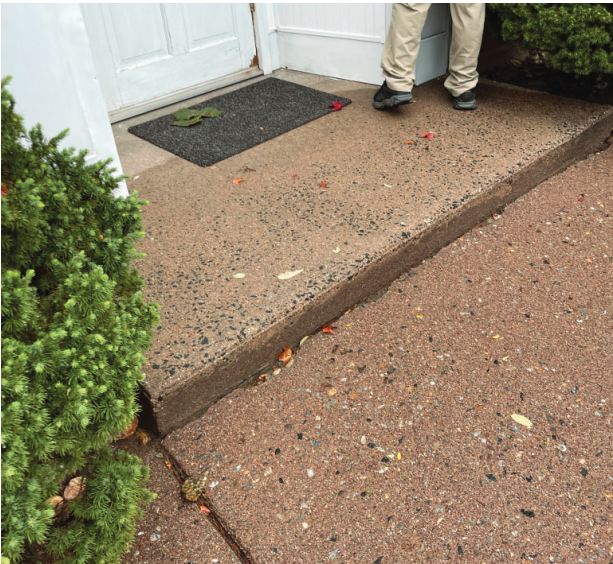
Step at Front Entrance, not compliant

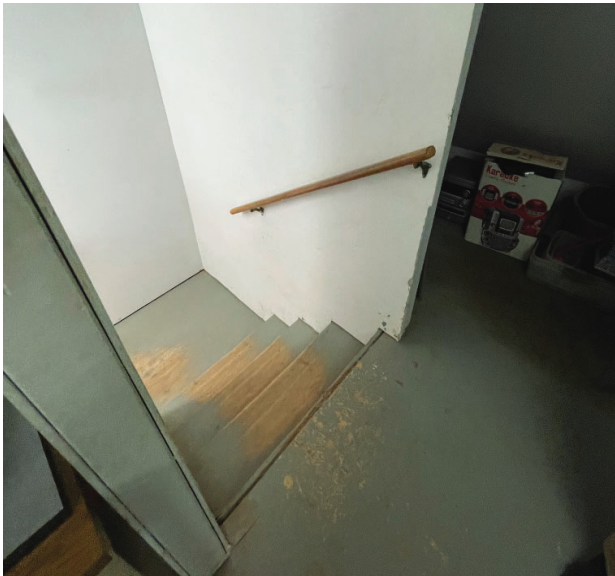
Stairway to Press Box

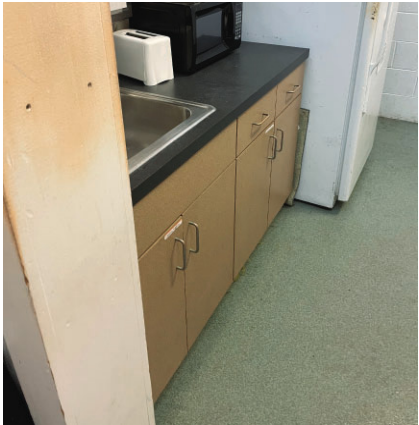
Casework Condition, Break Room

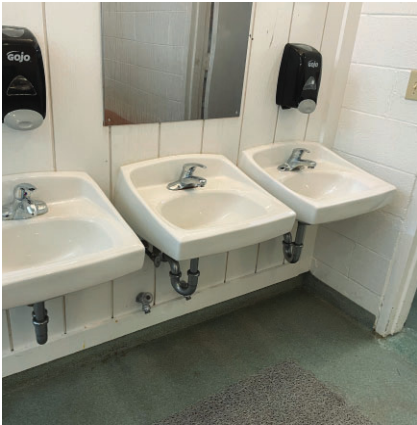
Sink Piping Condition, Locker Room

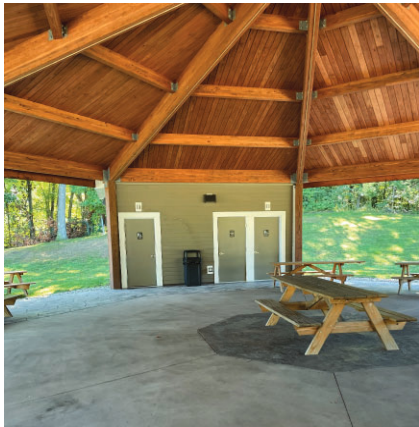
Signage condition

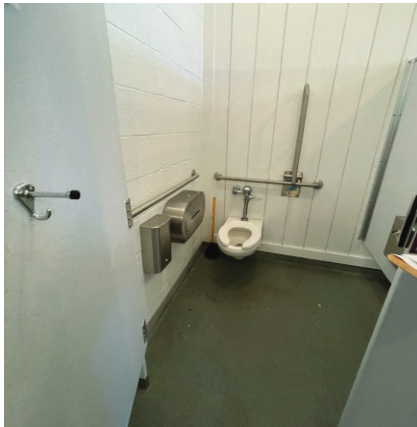
vertical grab bar missing

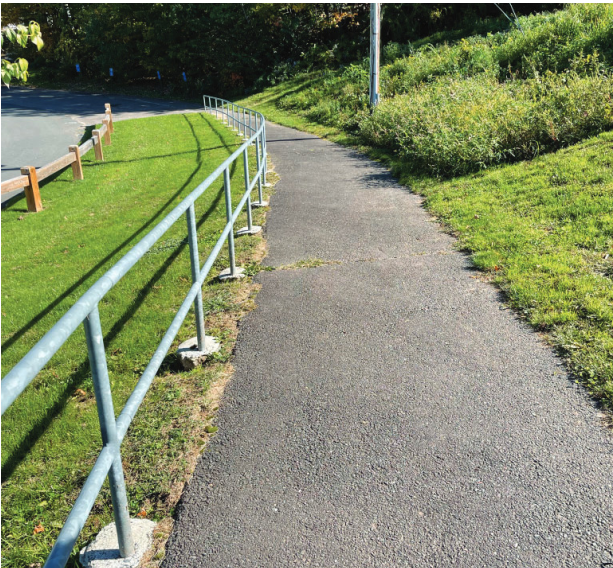
ADA Compliant Walkway, View from Ticket Booth (Top of Walkway)

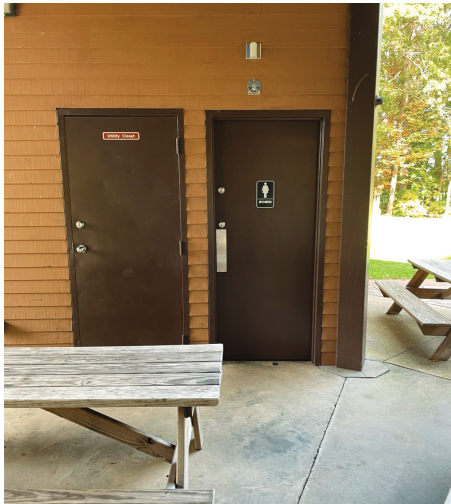
Signage on Doors, Not Compliant
